**COST Action TU0901:
Integrating and Harmonizing Sound Insulation Aspects
in Sustainable Urban Housing Constructions**

Building acoustics throughout Europe Volume 2: Housing and construction types country by country

Birgit Rasmussen & María Machimbarrena (editors), COST Action TU0901 –
*Building acoustics throughout Europe. Volume 2: Housing and construction types
country by country.*

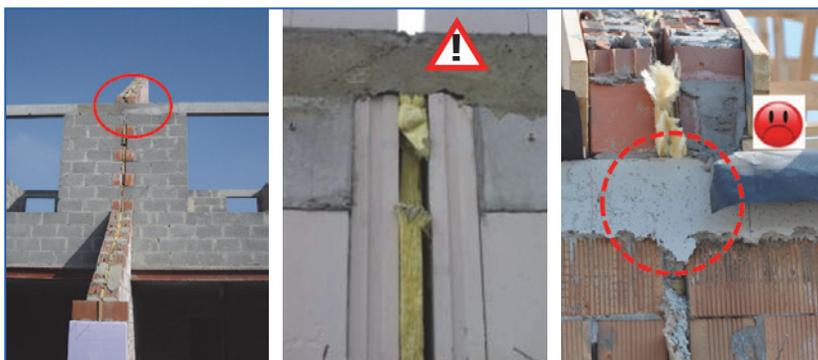
Figure 2.7. Hard connections (continuous floors, concrete beams but even small metal ties can largely reduce the sound insulation; the party wall loses its acoustic double wall behaviour and extra flanking transmission will occur.

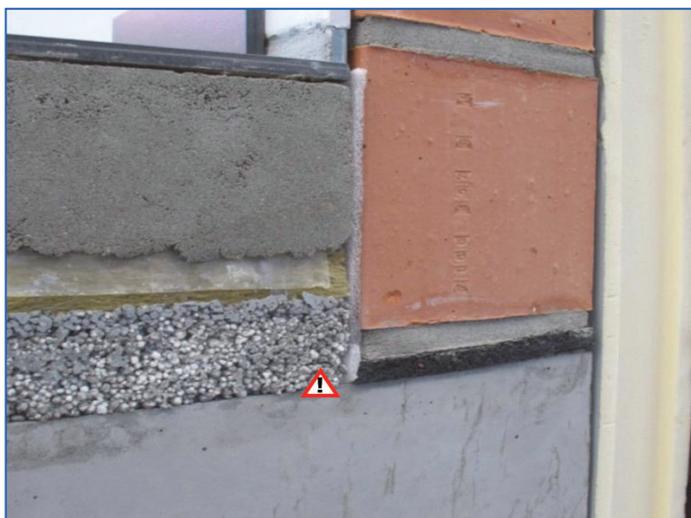
Figure 2.12. Detail of concrete slab with floating floor and acoustic strip (Sonic strip, Wienerberger – CDM). It is important to put a border resilient strip before executing the levelling screed to avoid a hard contact between the concrete slab and the brick wall!

- A great quantity of mortar bridges connecting the brick wall and the floor slab can deteriorate the sound insulation;
- When no elastic border strip is placed against the brick wall before pouring the levelling screed, then this latter can form a “vibration bridge” between the brick wall and the concrete slab, deteriorating seriously the sound insulation (see Figure 2.12);

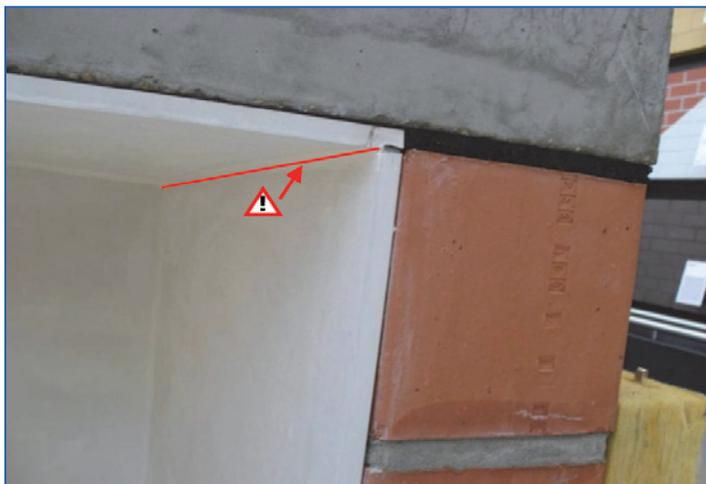
Figure 2.13. Detail of the acoustic strip below the concrete slab and on top of the wall. It is always important to cut the plaster at the junction between the brick wall and the concrete slab to avoid cracks (different thermal dilatation), but when using acoustic strips, it should be cut completely down to the acoustic strip and filled up with silicones to avoid a “vibration bridge”.

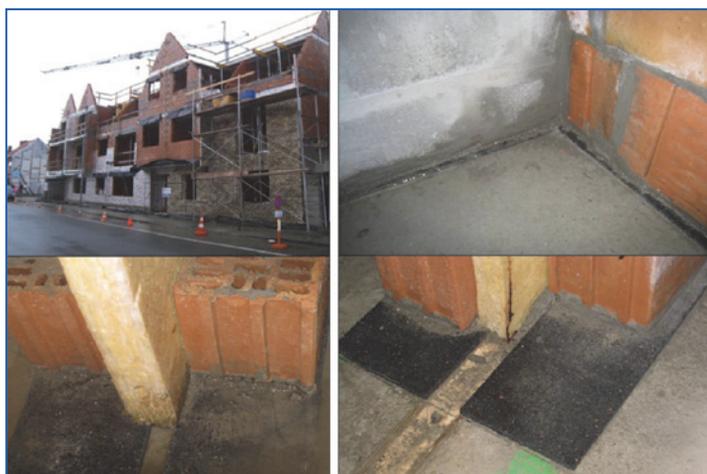
Figure 2.14. Application of acoustic strips below brick walls (party wall below) and concrete blocks (the elevator shaft). The acoustic strips (CDM, Sonic strips) have only a limited deformation (2 mm under the weight of the building, almost no creep in time).

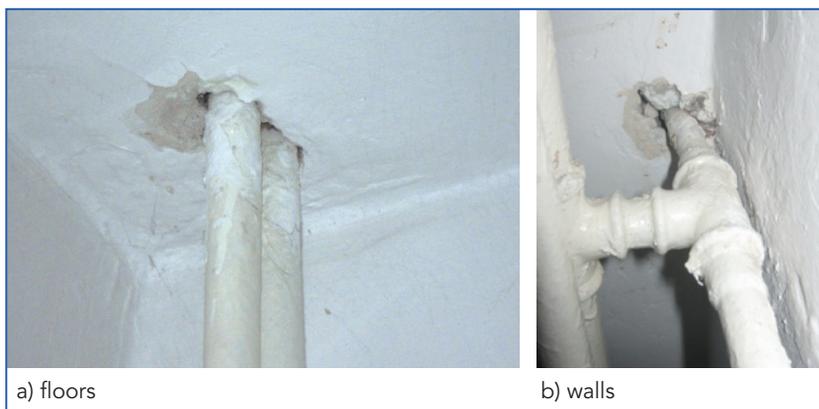
Figure 21.21. Typical errors for cross pipes.
